Summary

This profile provides an overview of water, sanitation and hygiene (WASH) infrastructure within Camp 6 in Ukhia, Cox's Bazar. Primary data for the sixth round was collected between 22 April - 12 May 2018.¹ Findings should be considered indicative only. The full camp dataset is available on [HDX](#).

Site Overview

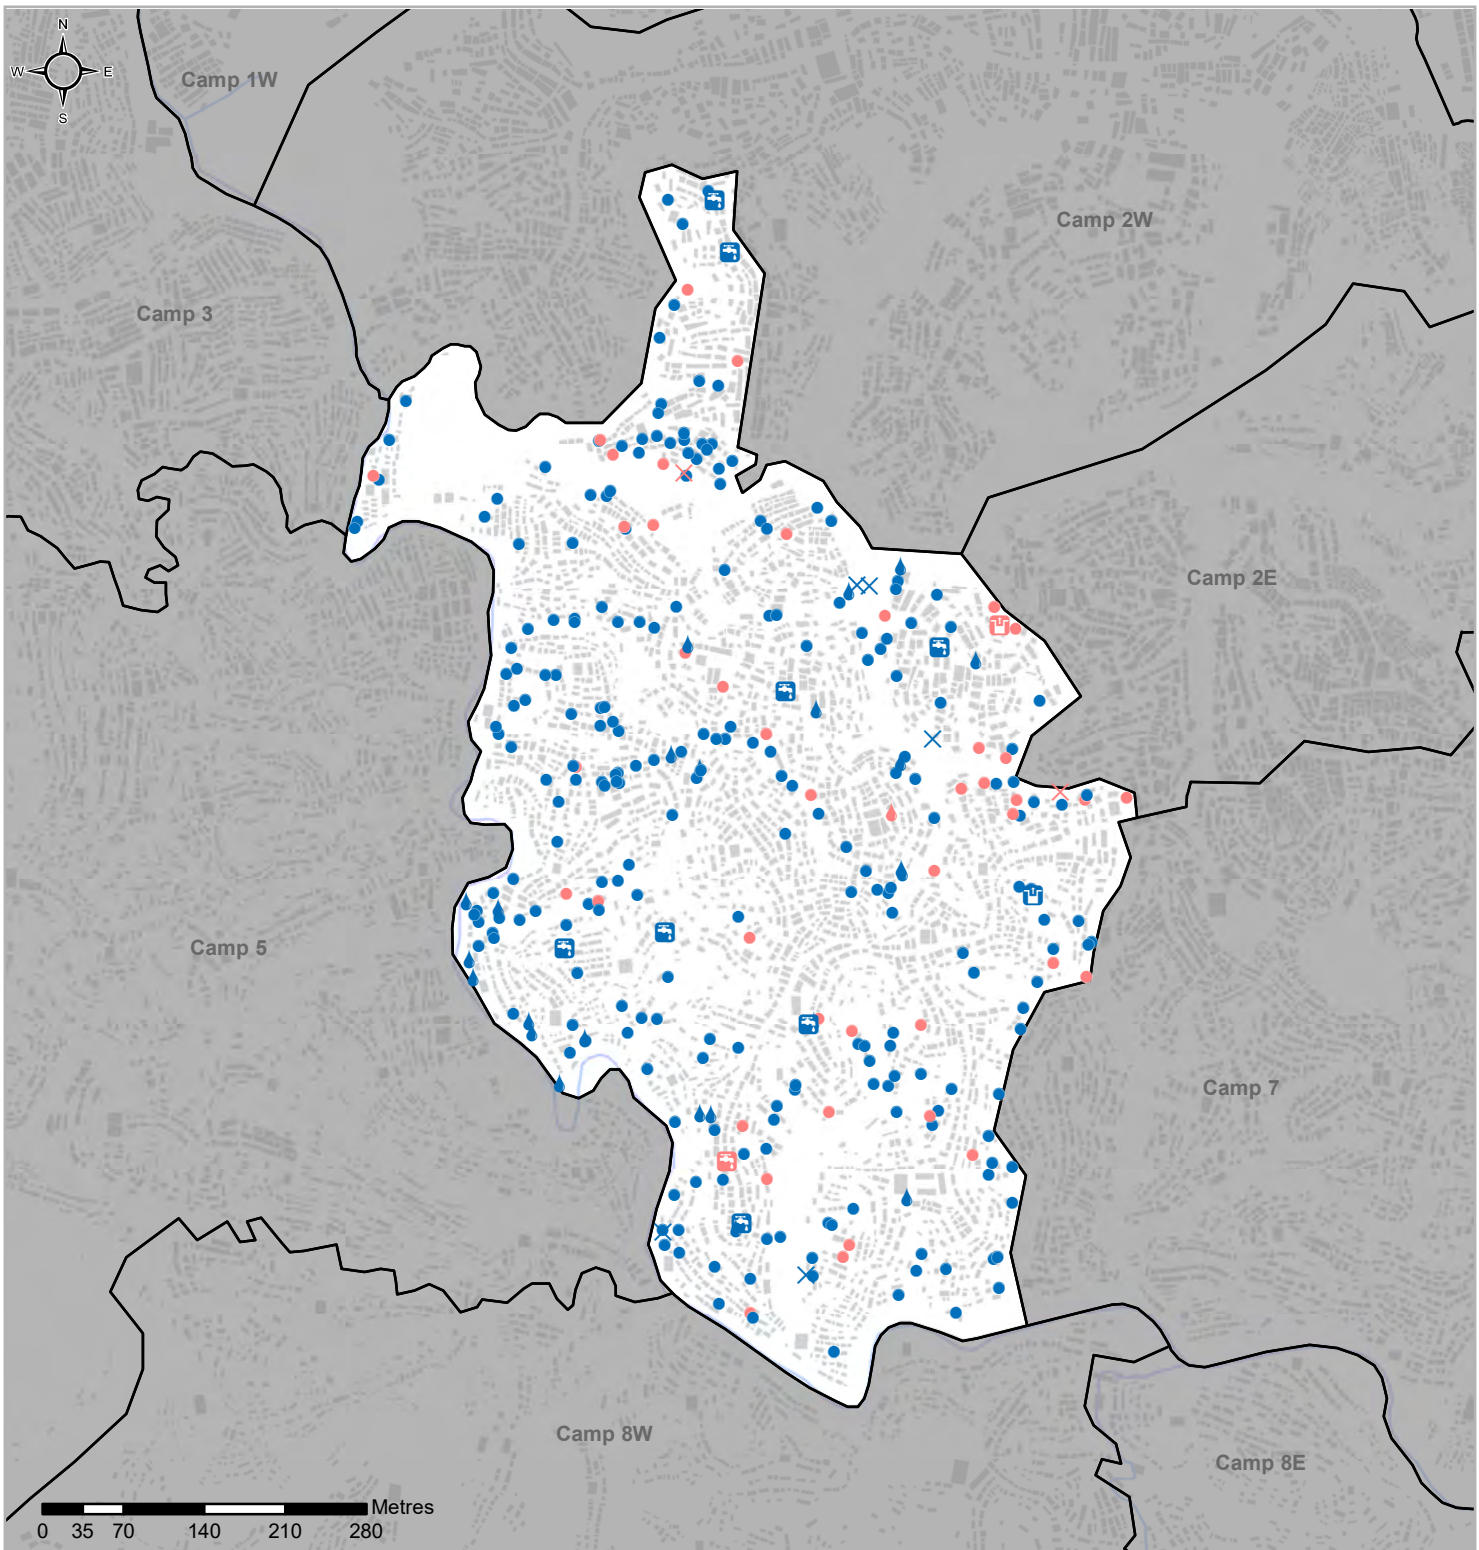
Water Access

Functioning	Non-functioning		
Hand pump / tubewell	230	42	Shelter	
Tapstand	8	1	Camp boundary	
Well	1	1	River	
Water tank	23	1	<i>The boundaries and names used on this map do not imply official endorsement or acceptance by the United Nations</i>	
Unimproved water source	5	2

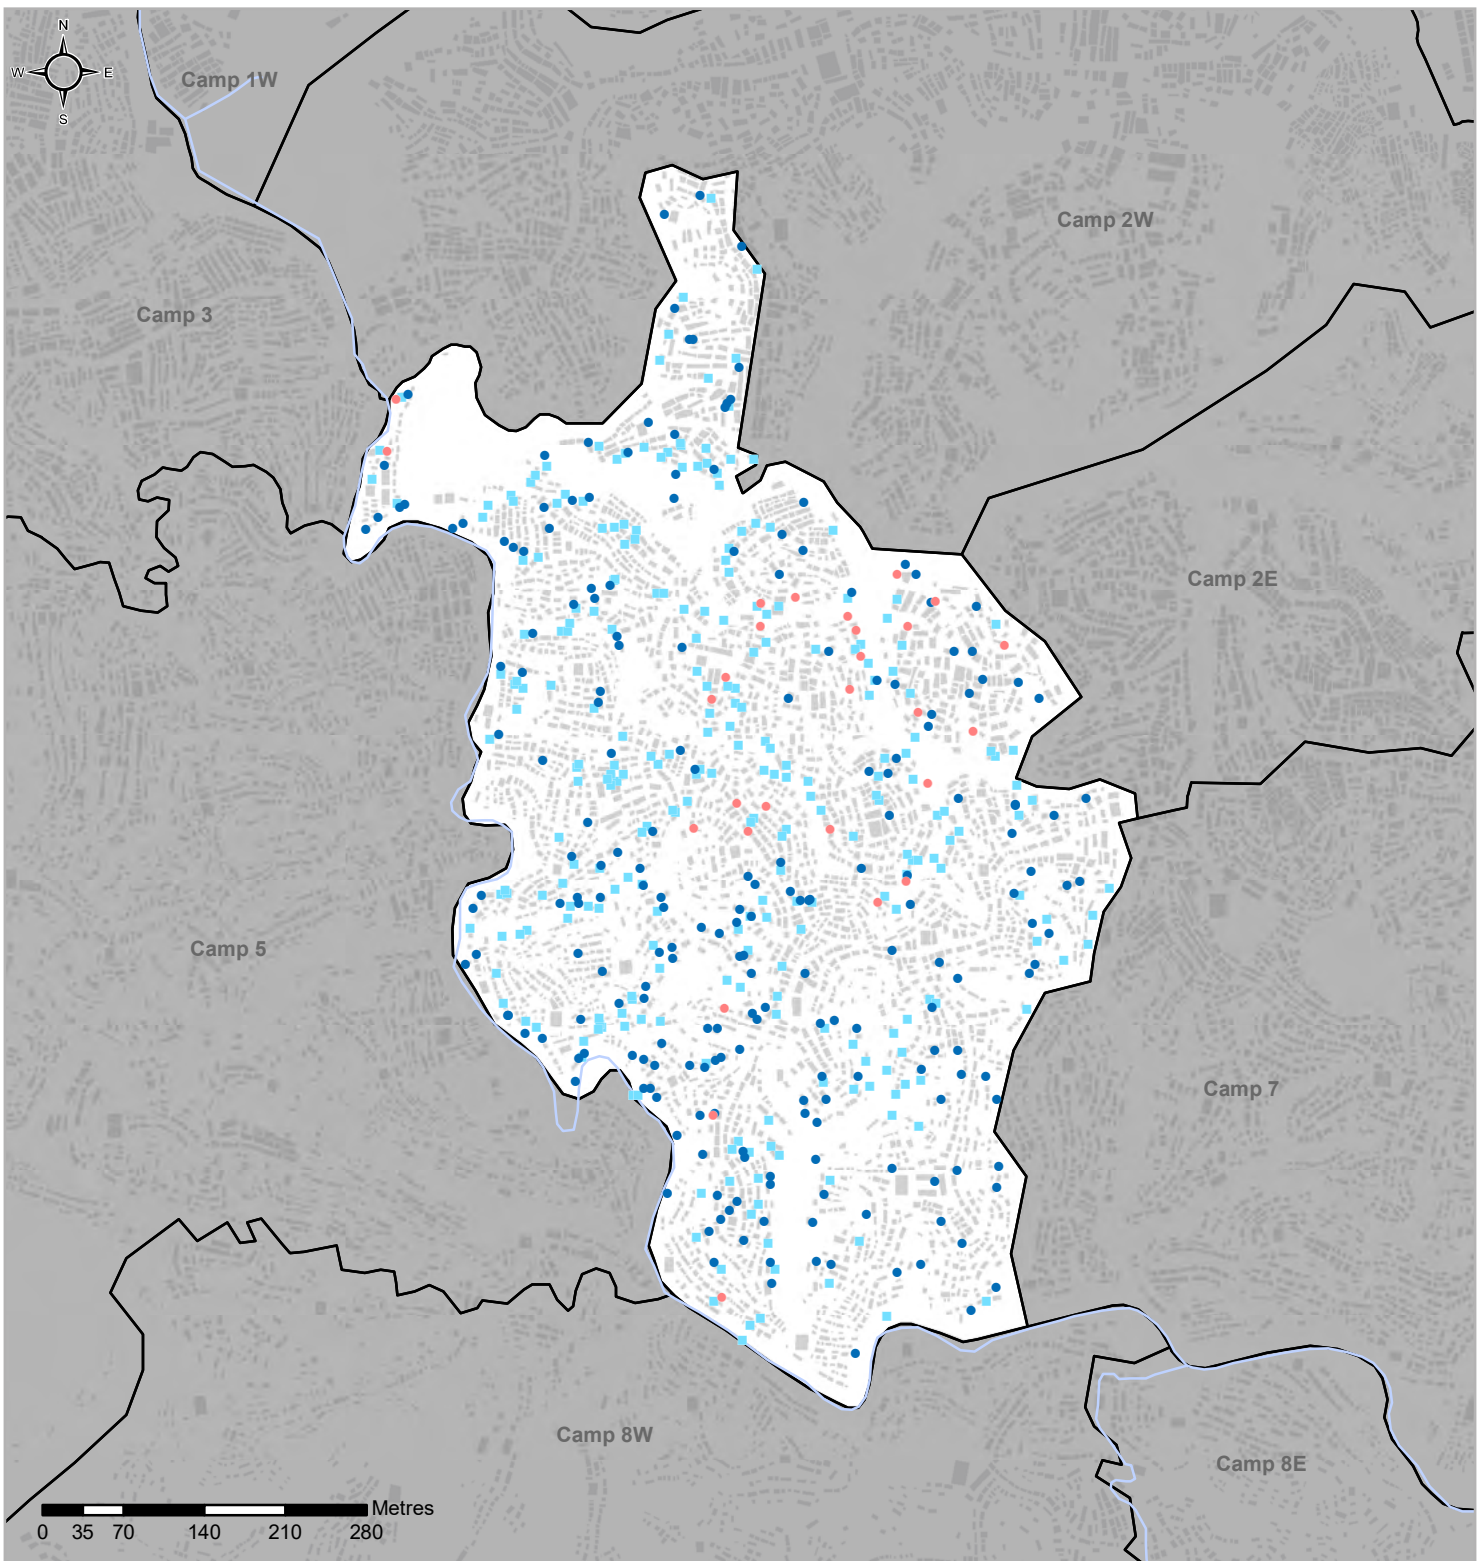
Sanitation

Functioning	Non-functioning	
Latrines	● 216	● 28	Shelter

WASH rooms	■ 269		Camp boundary
